NEWTOWN, CONNECTICUT

# HATTERTOWN POND DAM CT 00313

## PHASE I INSPECTION REPORT NATIONAL DAM INSPECTION PROGRAM

MAY 1981

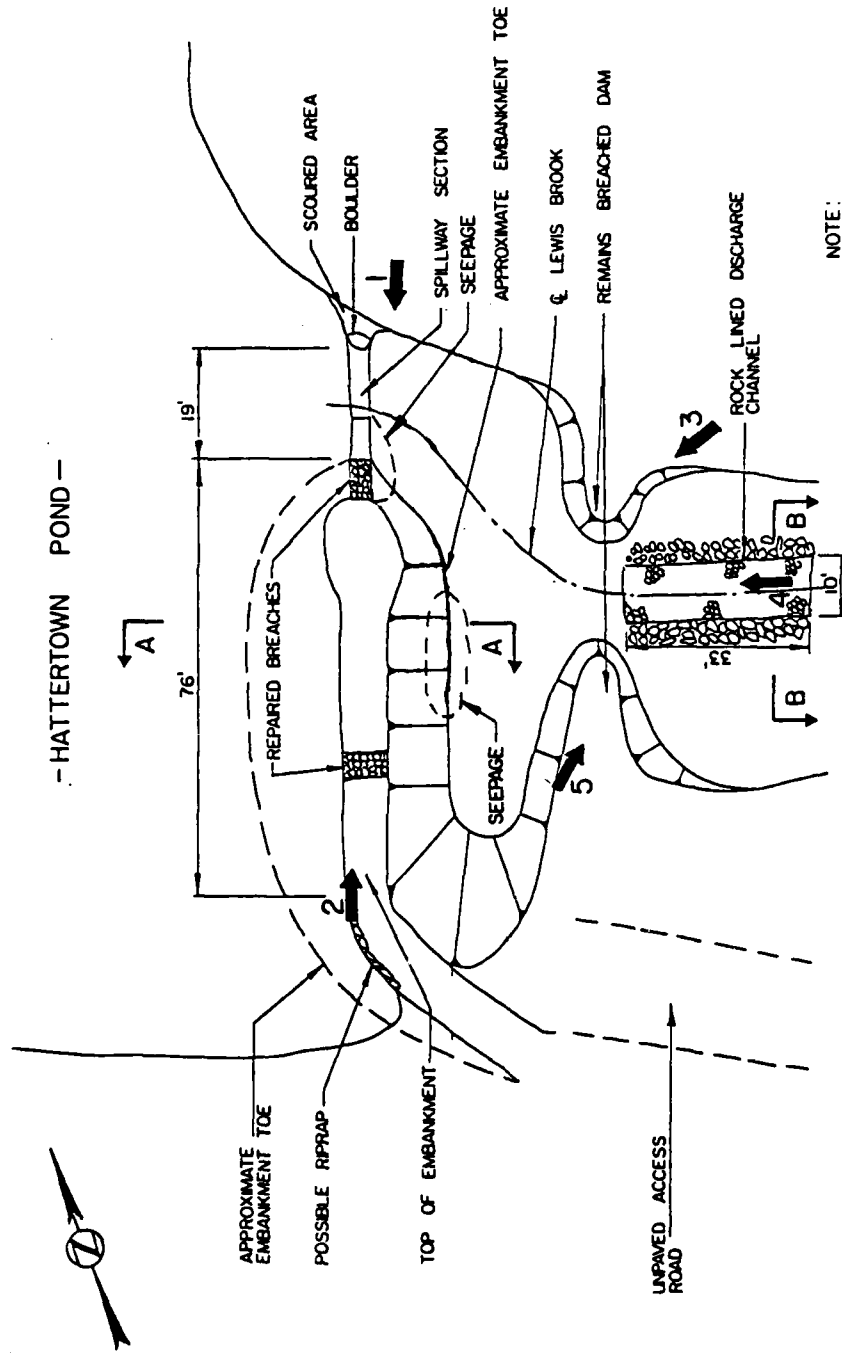
e. Downstream Channel — The downstream channel follows the natural path of Lewis Brook through a heavily wooded area. Lewis Brook then passes through another breached dam approximately 1,200 feet downstream of the pond before flowing under Castle Meadow Road (Photo 6). The 6-foot-high by 7-foot-wide breach and the 6-foot-high by 15-foot-wide bridge culvert compose the first downstream constriction.

NOTE:  
 PHOTO 6 WAS TAKEN WHERE LEWIS BROOK  
 FLOWS UNDER CASTLE MEADOW ROAD (SEE  
 DRAINAGE AREA MAP IN APPENDIX D FOR  
 THE ROAD LOCATION).

Photo 6 Breached dam near Castle Meadow Road bridge culvert.
